Subject: Metropolitan Wastewater Treatment Plant
Operating Permit 879-90-OT-3
Summary of Emergency Damper Leakage

SUMMARY OF
EMERGENCY DAMPER LEAKAGE

METRO PLANT INCINERATORS

September 1995 through February 1996

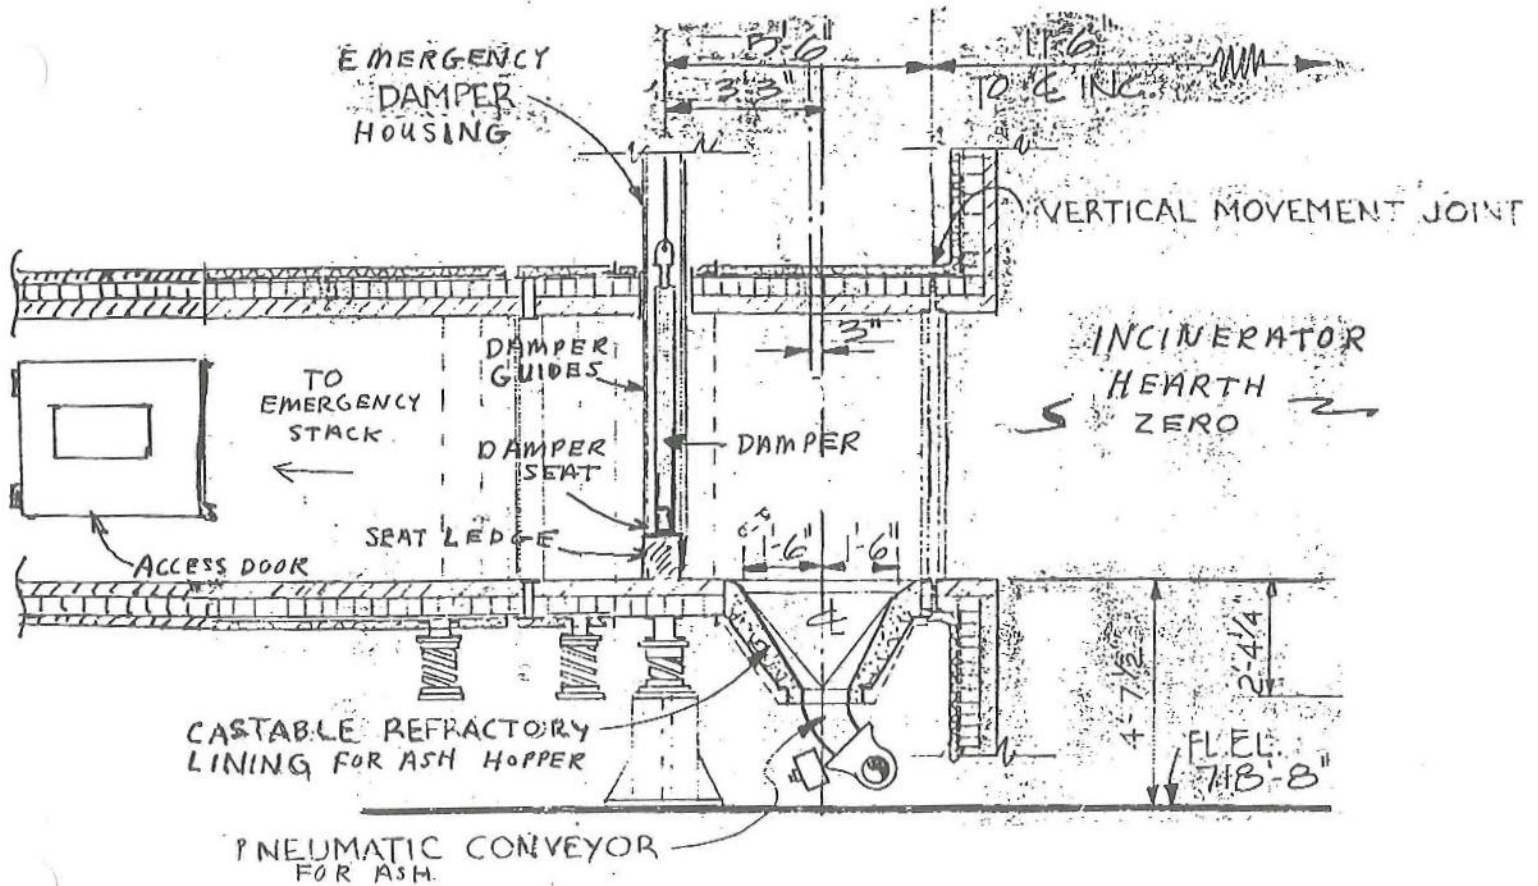
FIGURE 3
VIEW OF EMERGENCY BREACH/DAMPER FROM INSIDE HEARTH

The more important seat modification is the addition of a layer of ceramic fiber refractory material to the bottom of the metal damper frame, as shown in Figure 3. This material extends across the entire width of the damper, has a height of 6 inches and a thickness of 4 inches. The intent is to provide a compressible layer between the hard surfaces of the damper frame and refractory ledge. It will allow a good seal to be maintained if some ash lies on the ledge as the damper descends, or if the damper closes in an imperfectly level position.
